ROOTING CHARACTERISTICS OF VEGETATION ESTABLISHED ON A REFUSE PILE

Priscilla Burton, Paul Baker, and Susan White, Utah Department of Natural Resources,
Division of Oil, Gas & Mining, 1594 West North Temple, Suite 1210, Salt Lake City, Utah
84114-5801

ABSTRACT

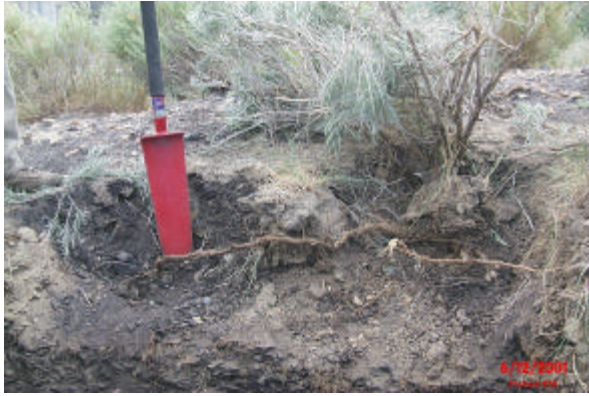
except *Eriogonum corymbosum*¹, dramatically turned to grow along the soil/refuse interface before eventually descending gradually, but not vertically, into the refuse, see Picture #1. These tap roots were very gnarled, see Picture #2 versus Picture #3.

Picture #1, Refuse Pit #2. Taproot growing sideways. (The red portion of the Sharpshooter shovel is 18 inches long.)

Root growth into soil-covered refuse would be enhanced by ripping of the surface prior to soil cover placement. The recommended depth of ripping is inversely related to the depth of cover, so that a less compacted root zone of four feet is achieved. If the refuse is combustible then the recommended soil cover depth should be four feet to allow for a rooting zone, while protecting against combustion. Working the soil cover into the refuse surface to avoid an abrupt boundary layer is also recommended.

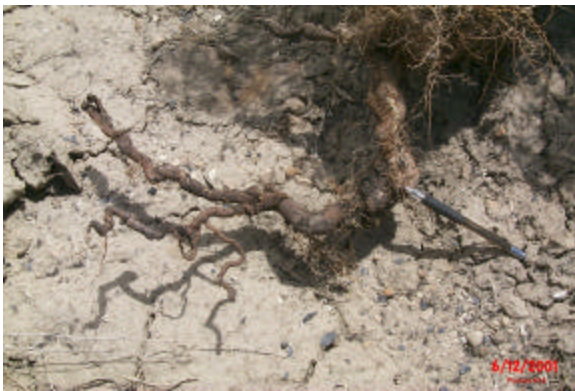
Picture # 2, Refuse Pit #2. Gnarled roots.

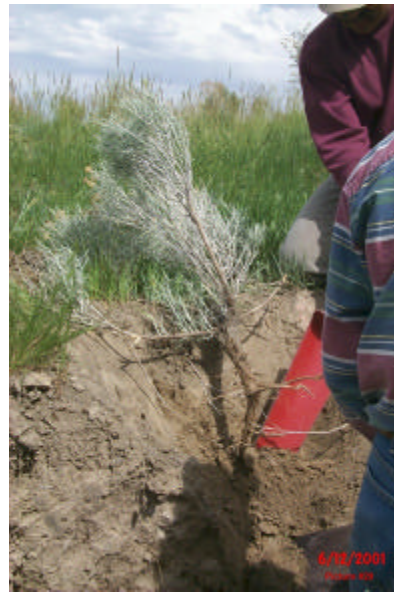
Picture #3, Subsoil Pit #1.
Normal roots

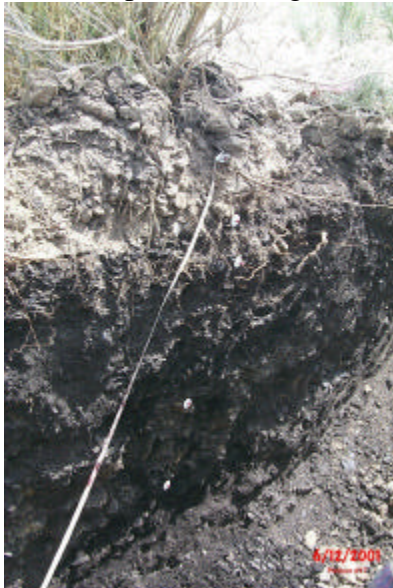
The soil and refuse were very dry and very hard to dig. The roots formed a mat of fine roots at the soil/refuse interface at Pit #2 south side, Pit #3 east and west sides, and Pit #4 north and south sides, for example see Picture #4. Within the refuse, root growth was noted in mats

Picture #4, Refuse Pit #2 south side
Mat of fine roots at the soil/refuse interface.

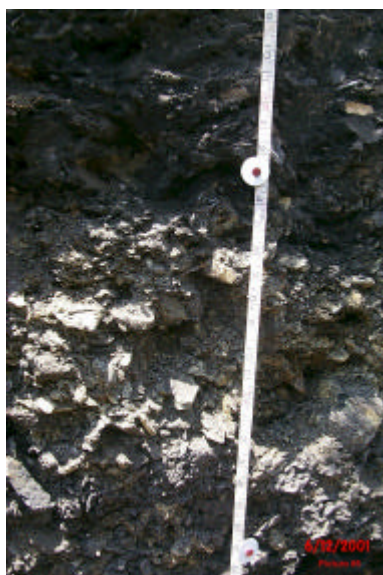
Coarse fragments in the refuse were stained with iron and sulfur precipitates at four out of the five pits, suggesting some acid formation (see Picture #5). In response to testing with hydrochloric acid the refuse showed no effervescence, indicating that there are no carbonates present and it has no buffering capacity for any acidity it produces.

Picture #5, Pit #1 west side
Iron and Sulfur precipitation.

Although iron and sulfur staining was noted in most of the refuse pits, it is unclear if the lower pH had any effect on plant root growth, but the presence of fine and very fine roots in the refuse would indicate that they were not adversely affected by the refuse pH.

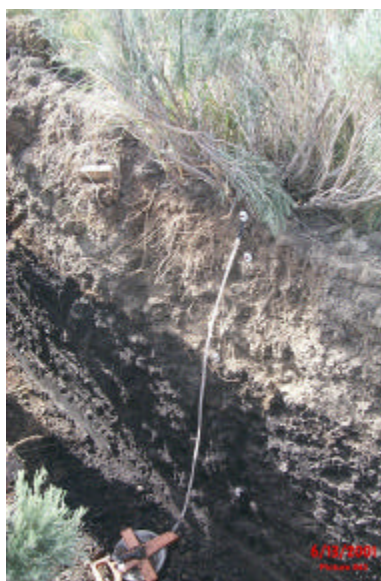
Picture #6, Pit #4 south side
Compacted Refuse

Refuse structure was massive and difficult to dig even with the trackhoe (see Picture #6, Pit #4 south side). The compaction of the refuse was noted by measuring the resistance to penetration with a pocket penetrometer. When the refuse was dry, it was impenetrable. When moist, it still presented a very hard surface requiring four times as much pressure to penetrate as the subsoil above it.

Compaction and moisture may have played a role in the differences. Compaction of refuse piles is required under Mine Safety and Health Administration regulations at 30 CFR 77.215 as a strategy to avoid combustion. As discussed earlier, Dames and Moore recommended a compaction of 75 pounds per cubic foot for the refuse material when it was placed in the test plot area of the refuse pile sometime between 1976 and 1982. A 1982 photograph of the refuse prior to installation of the test plot shows a two-track road going up the ridge of the pile. Our rooting depth study pits were in the same approximate location as the road. As demonstrated by the penetrometer readings the refuse remains well compacted, even when moist.

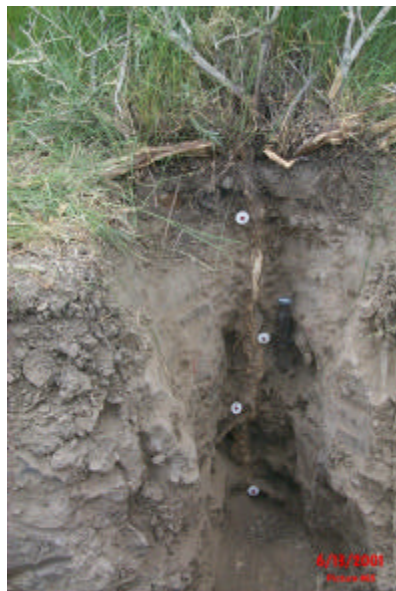
At the subsoil pile, taproots of the following shrubs were exposed: two four-wing saltbushes (*Atriplex canescens*); two whitestem rabbitbrushes (*Chrysothamnus nauseosus* var. *albicaulis*); and two greenish rabbitbrushes (*Chrysothamnus nauseosus* var. *consimilis*). All shrub taproots were quite robust and grew straight downwards into the subsoil stockpile (see Picture #7)

Picture #7, Subsoil Pit #3
Taproot growing straight down into subsoil.

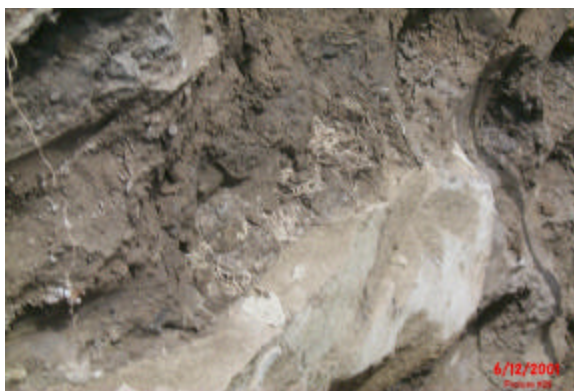
At Pits #1 and #3 in the subsoil very few fine to very fine roots were noted clustered around a large rock (see Picture #8). This is similar to what was noted in the refuse.

Picture #8, Subsoil Pit #
Roots clustered under rock in the subsoil.
